Service Bulletin

EAS 911 Memory Loss Prevention

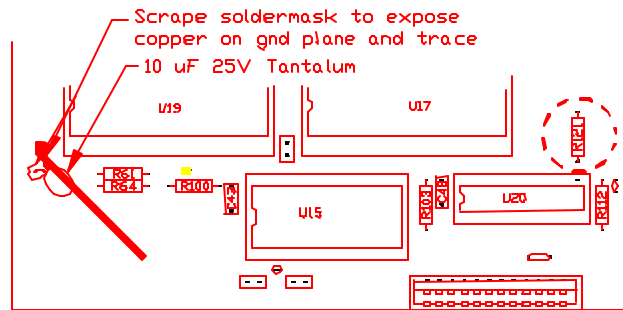
In some very rare and unusual circumstances, the EAS 911 may lose portions of its setup memory.

1. One possible cause has been traced to the combination of an IC's input leakage current and its pull-down resistor. The input of Gal U20 is pulled high during factory test and resistor R121 pulls the input to ground during normal operation. If the leakage current is excessive, the input can appear to be logic 1 instead of its normal logic 0.

A preventive measure can be accomplished easily in the field:

Save all set-up parameters before powering down the 911 unit. With AC Power off, on main board assembly, replace R121 with a zero-Ohm resistor or jumper wire or simply solder a shorting wire across the resistor. Erase all set-up parameters before powering up the 911 unit again. This is accomplished by placing a piece of paper between BATT1 and its contacts for 15 minutes. If the board does not have BATT1, carefully remove U15 from its socket for 15 minutes, then reinstall it. See Fig. 1 (W/O Batt1) or Fig. 2 (W/Batt1)
